**RESTORATION OF
KANSAS STATEHOUSE**

Restoration of Kansas Statehouse's, Topeka, Kansas (USA)

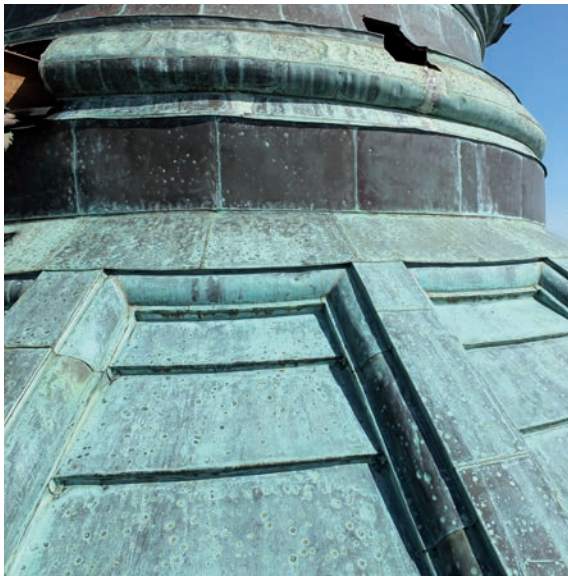
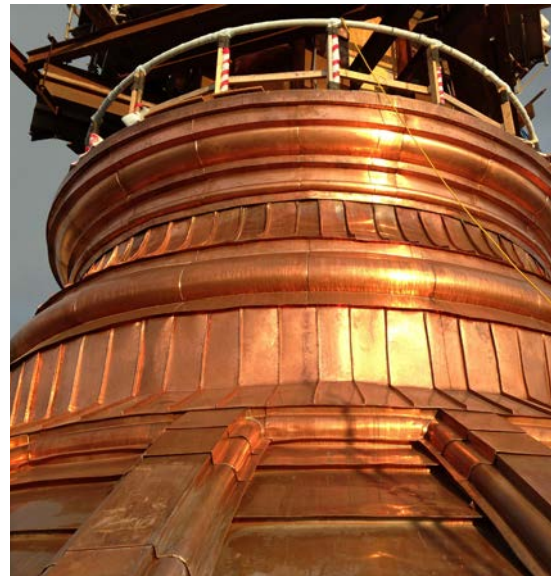
come. From the preexisting dome, the scales of original copper were recycled, portions of which were reused to produce jewelry and other gifts available in the visitor's center. Installed by Baker Roofing, the dome is covered with nearly 25,000 square feet of 20-ounce copper horizontal-seam roofing panels joined at ribs moldings custom fabricated by Ornametals.

BEFORE

AFTER

The entire roof had been badly damaged by wind and hail. The most serious long-term damage to the dome, including major leaks, was caused mainly by the traditional 19th century soldering methods used to assemble it, which did not allow for expansion.

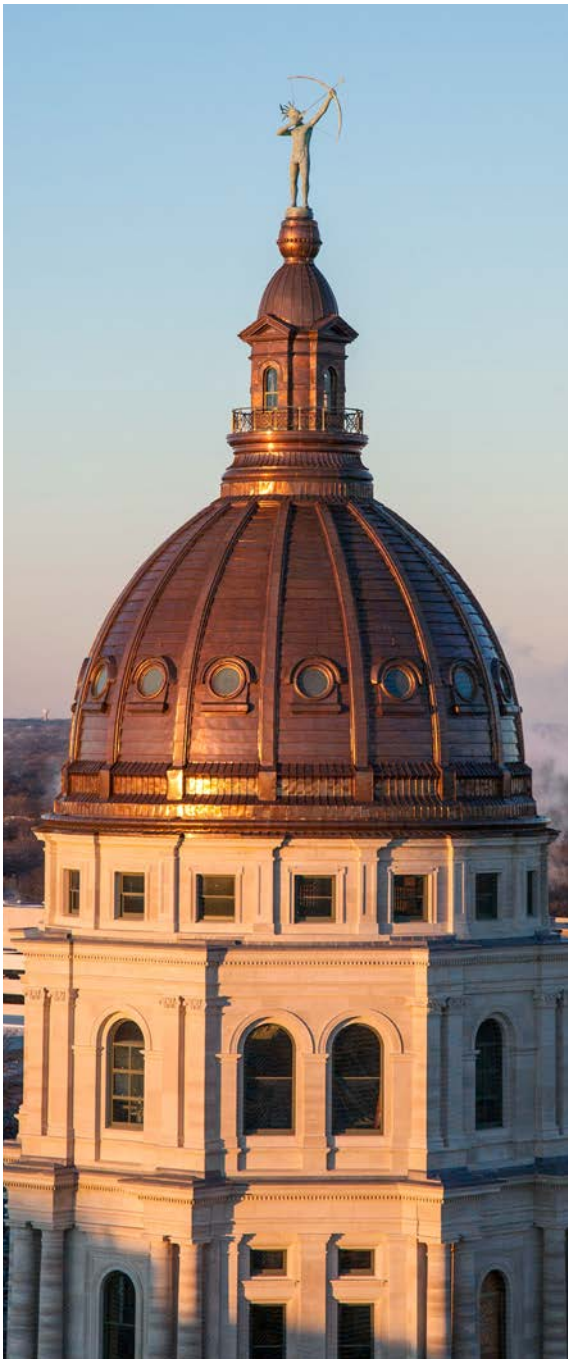
In addition to these panels, the dome incorporated new copper window surrounds, stainless steel gutter frames, heat trace, roof drains and lightning protection

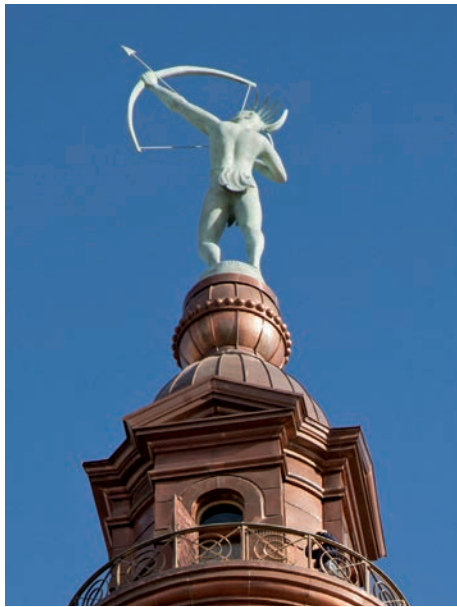
“Ad Astra” is a 22-foot sculpture of a Kanza Indian warrior aiming an arrow at the North Star that was placed on top of the dome in 2002. Its title is taken from the state motto, “Ad Astra per Aspera,” which means “to the stars through difficulties.” The sculpture, hollow cast of silicon bronze, weighs 4,420 pounds.

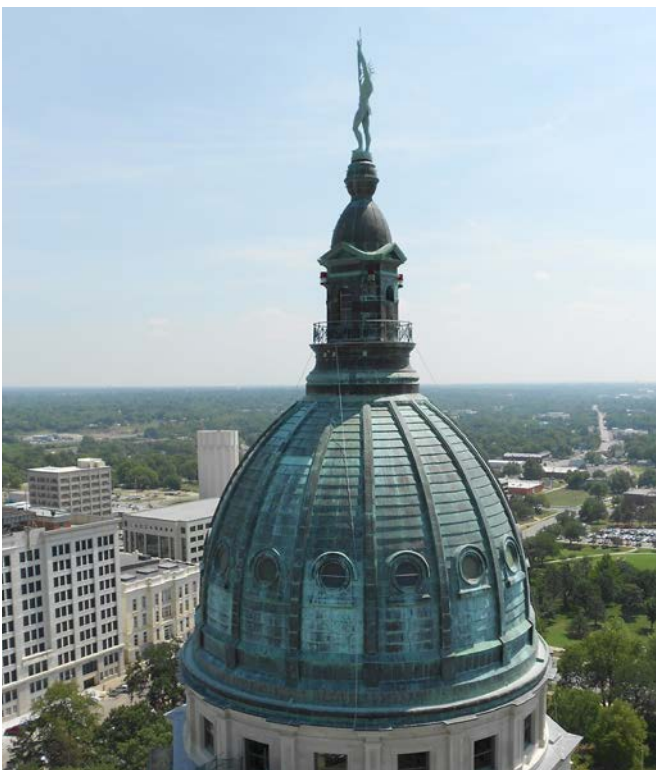
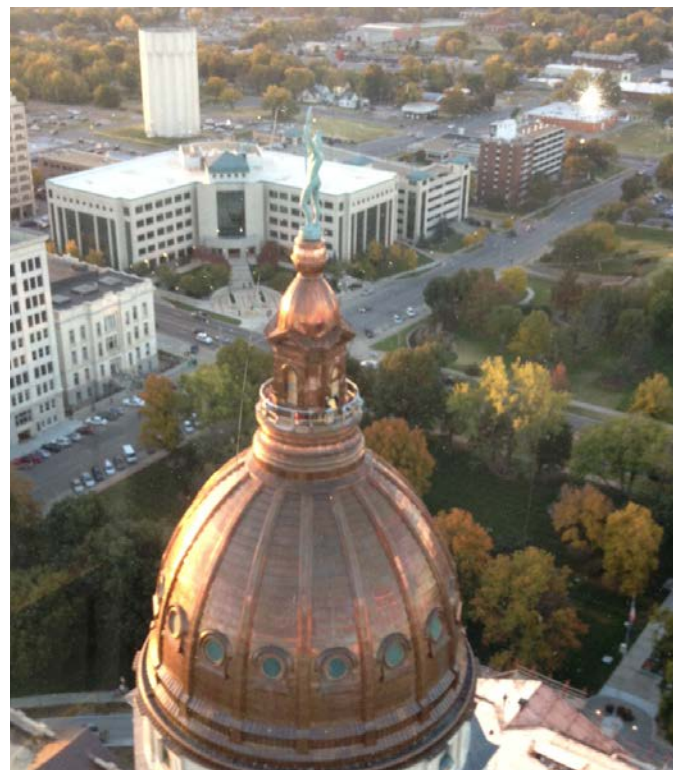
The biggest challenge was to copy the existing design, with all details included. The original supporting frame had to be partly replaced. The hips were quite complex, curved and tapered at the top.

BEFORE

AFTER

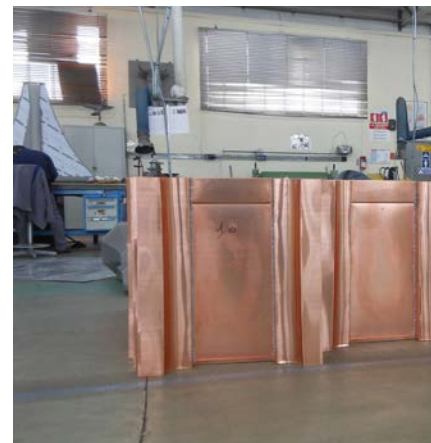
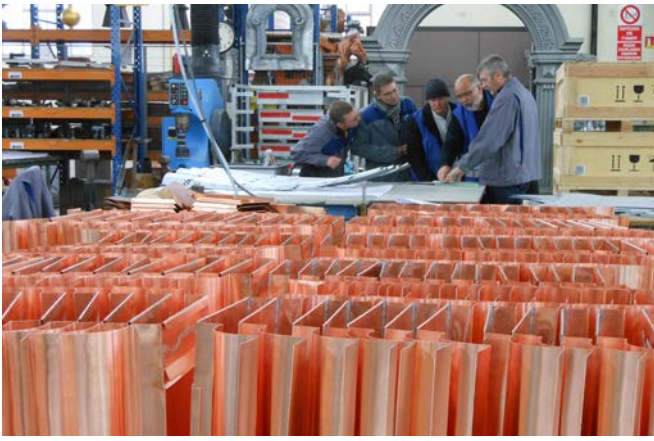
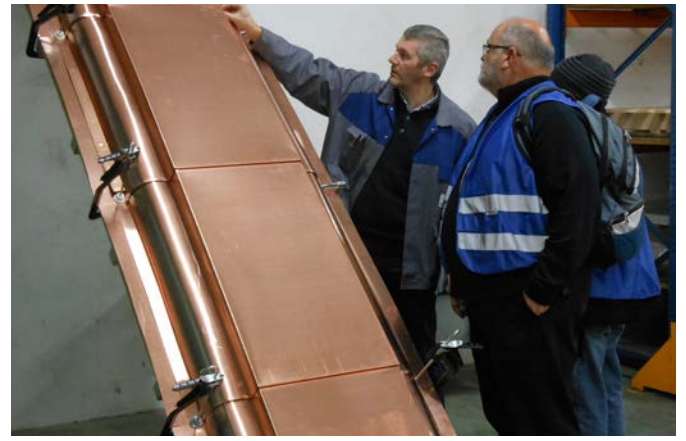
To design the 340 copper parts for the new dome, the VMZINC® Ornaments teams used all their know-how, inherited from 19th century craftsmen. From matrix through to laser cutting, the new parts produced demonstrate the teams' perfect mastery of metal transformation.

“On top of these traditional production techniques, we added a complementary approach proposing numerous 3D drawings” says Sammy Baron. These drawings made it possible to check the adjustment of all parts and provide the architect and the company with an overview of all the elements to be produced and installed. This simplified work during the crucial installation phase and ensured a better end result.
